BF90-001

ITB90-003A

Q45 WIND NOISE

1990 Q45

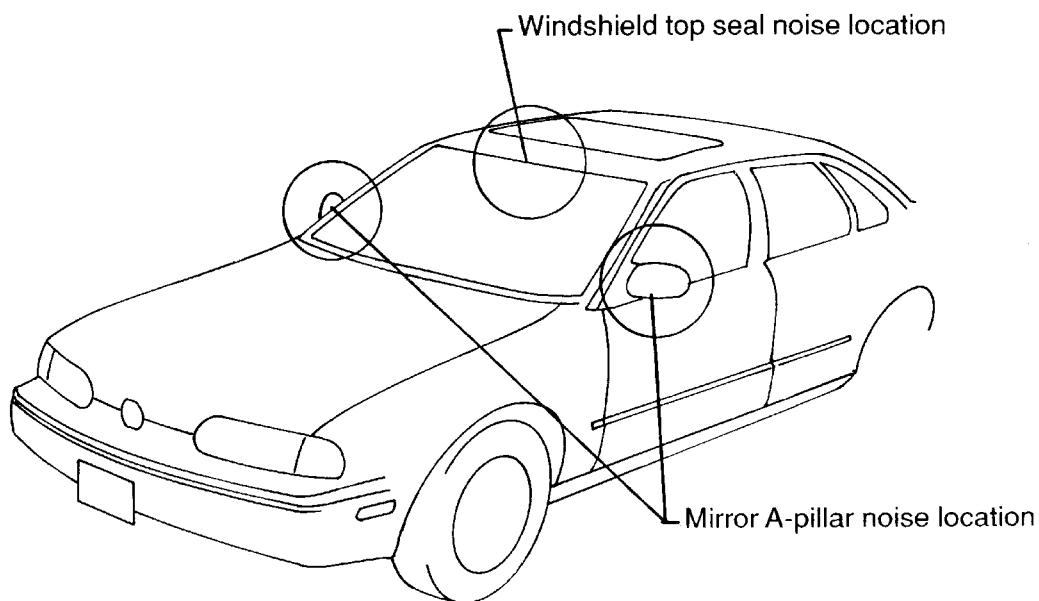
Figure 1

On some 1990 Infiniti Q45 vehicles, an air/wind noise may be heard coming from the windshield, dash and/or A-pillar areas (Figure 1). This noise occurs when the vehicle is driven at speeds above 40 MPH. Use the following "Service Procedure" to verify the noise location and to determine the appropriate repair procedure to eliminate the noise source.
