SERVICE BULLETIN

Classification: EC95-001 Reference: ITB95-020

DECREASED ENGINE DRIVEABILITY and/or CHECK ENGINE LIGHT ON (CODE 45 - INJECTOR LEAK)

APPLIED VEHICLE(S): All Infiniti vehicles (except OBD-II equipped vehicles)

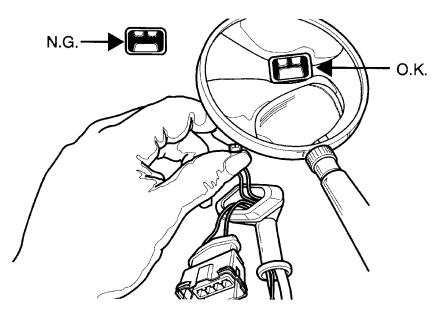
4. Remove, inspect, and reinstall the female pins at the MAFS harness connector ONE AT A TIME. Carefully push the connector and wire out through the back side of the connector. Use a <u>modified</u> Kent-Moore tool J38751-305 (modify by increasing the length of the working end of the tool about 1/4" - this can be done with a grinder or file) Extract the individual pin by releasing the locking tab with the special tool through the recess on the component side of the connector. Inspect the contact surfaces of the pin for any corrosion or damage. The female pins contact force should be checked by sliding the female connector over the appropriate male pin on the MAFS and checking for a snug fit. The contact force can be increased by bending the contact springs toward each other slightly with an appropriate tool.

- If any of the pins appear to be damaged, or if the wire is not properly crimped onto the female pin the terminal pin must be replaced. The terminal pin connector P/N is J38751-50. The wire seal P/N is J38751-48. Both parts are available in the Kent Moore terminal repair kit. Crimp and solder the new terminal pin on to the harness wire.
- 6. After all the female pins have been inspected/repaired, reattach the MAFS connector and perform tests 1 and 2 above to verify repair.

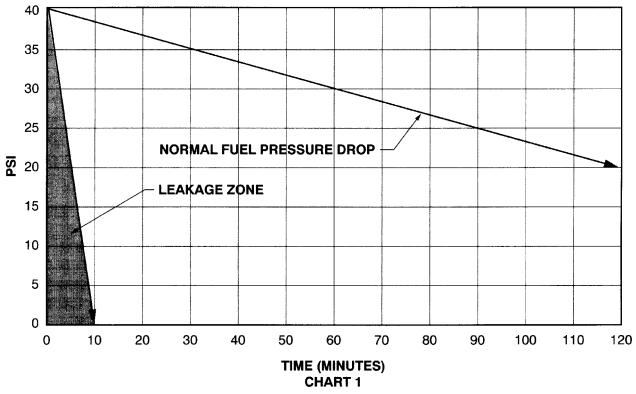
Note: An initial rise in pressure of 2-5 PSI is normal on a cold engine. A warm engine will have a larger rise in pressure.

Note: If there is an actual leaking injector (s), the fuel pressure will fall to 0 PSI within about 10 minutes. The time will depend on the severity of the leak or the number of injectors leaking.

INJECTOR DETERMINED TO BE LEAKING: AFTER REPLACING THE LEAKING INJECTOR(S) CONTINUE TO CHECK FOR SENSORS THAT CAN CAUSE A RICH CONDITION. REPLACE THE ENGINE OIL AND ENGINE OIL FILTER BECAUSE OF FUEL IN OIL.

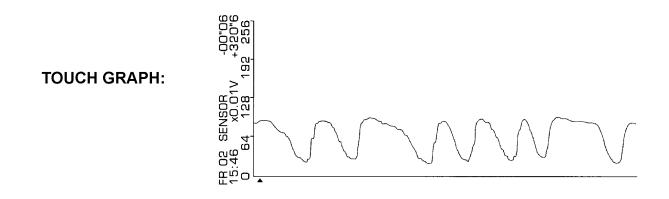
The O₂ sensor voltage should fluctuate between 0.0 and 1.0 Volts when graphed as shown above. There should be at least 5 peaks upward and 5 peaks downward in a ten second period. The peaks should look similar above 0.5 volts and below 0.5 Volts. A rich mixture will cause the voltage to stay closer to 1.0 Volts, and the graph will have fewer voltage fluctuations.

- A. If the O₂ sensor voltage appears NG then check the harness:
- B. Turn the ignition switch "OFF".
- C. Disconnect the ECM harness connector and O_2 sensor harness connector or heated O_2 sensor harness connector.
- D. Check the harness continuity between the ECM O₂ sensor signal terminal and the O₂ sensor signal wire terminal at the harness connector itself. There should be no resistance.
- E. If there is resistance in the wire, inspect the harness to determine the cause.
- F. Check the O₂ sensor signal wire for any continuity to ground, there should be no continuity (infinite ohms).
- G. If there is continuity to ground, inspect the harness to determine the cause.
- H. If the harness checks OK, but the consult reading is NG, check the ECM and harness connectors carefully for any damage or corrosion. If all harness checks are OK, then replace the O₂ sensor.
