BF90-008

ITB90-026

## DOOR KEY LOCK CYLINDER REMOVAL

1990 Q45

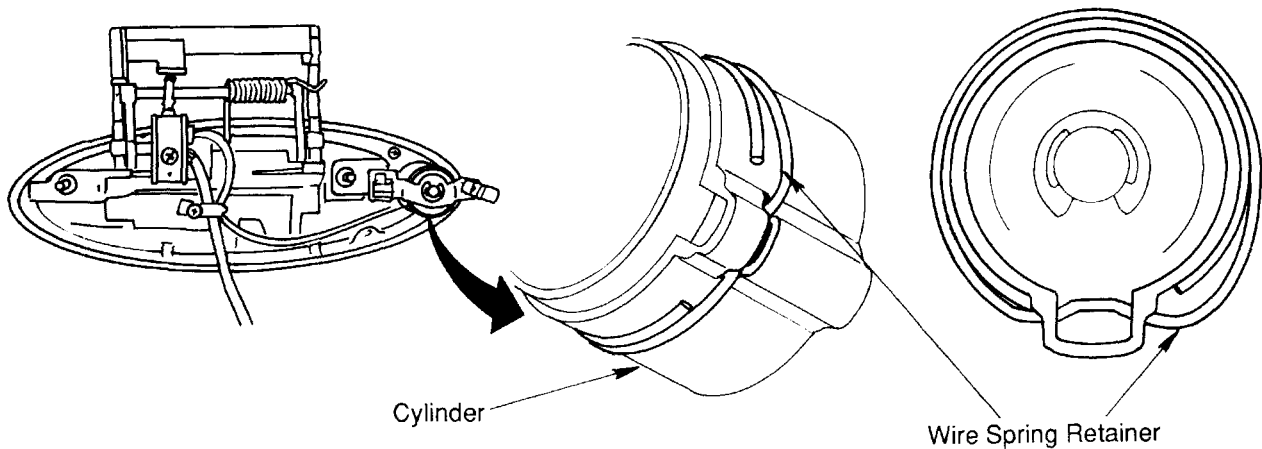
Figure 1

When removing or replacing the Q45 door handle or Vehicle Security System [V.S.S.] tamper switch, the door key lock cylinder must be removed. The cylinder is secured to the door handle by a wire spring retainer, P/N XA1HA-06501XX, (Figure 1).

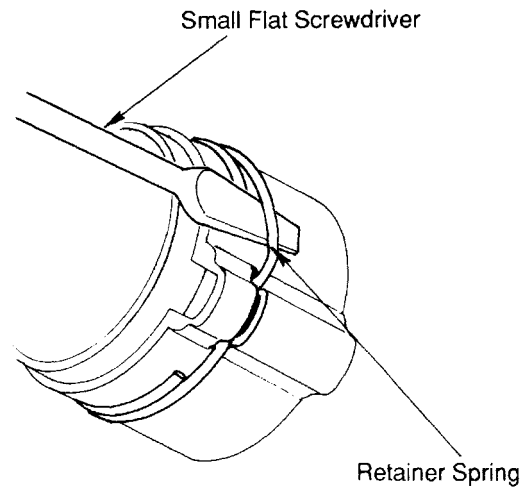
Figure 2

3. While pulling the handle assembly outward, use a small flathead screwdriver and, from the outside, lift the spring retainer away from the lock cylinder, allowing it to release from the door handle (Figure 2).

4. Reassemble the lock cylinder into the door handle assembly. The lock cylinder should snap easily back into the door handle after resetting the retainer spring into the latching position.
